EXPERIMENTAL INVESTIGATION OF FAILURE OF HIGH STRENGTH STEEL ON ACCOUNT OF EXTERNAL HYDROGEN EMBRITTLEMENT & EFFECT ON MECHANICAL PROPERTIES

AMIT KHARE¹, Dr. MANISH VISHWAKARMA² & Dr. SIRAJ AHMED³

ABSTRACT

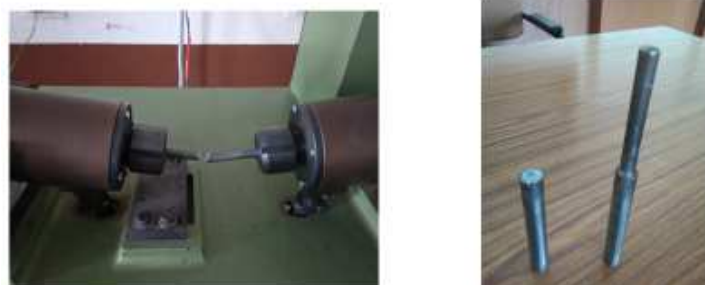
Figure 2: Rotating Bending Fatigue Test

Further fatigue test (rotating bending) & Impact (Charpy) are performed on pre-charged test specimen with charging parameters as indicated in table 3.

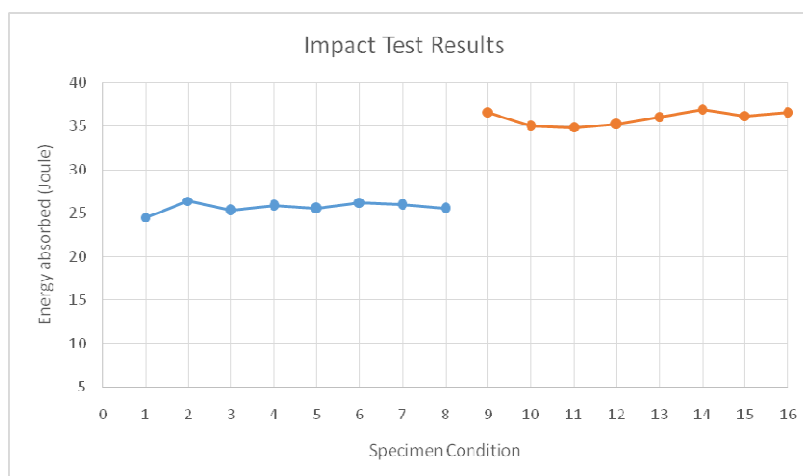
Figure 5: Impact Strength Comparison for Various Condition of EN 24 Material.

- As documented in literature review it is found that hydrogen presence in the microstructure has no effect on impact strength.
- This may be attributed to fact that sudden loading does not allow the hydrogen atoms to affect the fracture mechanism.
- As there is no significant change in impact properties, this can be concluded the hydrogen embrittlement does not affect material properties for impact loading condition.
- From the results, it was found that the energy variation during all experimental work has not changed widely and variation was found to be $\pm 4\%$. So it is concluded that the impact strength of material has not affected widely due to hydrogen diffusion.

- Impact strength is not affected by H-charging as this does not allow the diffused hydrogen to affect the fracture pattern owing to very high strain rate.

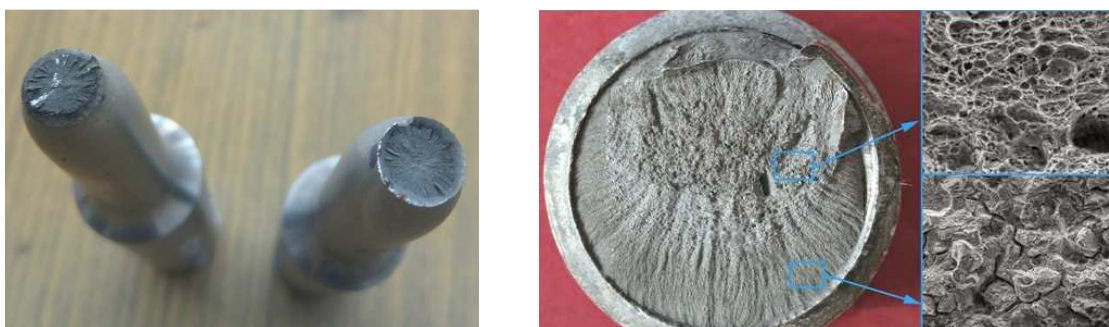
Figure 7(a&b): Fracture Modes After Tensile Tests.

Type of fractures seen during failure of test specimen are: (i) ductile cup-cone failure and (ii) shear fracture as shown in Figure 7a & 7b. Necking observed in cup & cone fracture of mild steel charged and high tensile steel charged specimen indicates ductile failure.

Figure 3b indicates Brittle Fracture with very little necking having three zones as: (i) crack initiation; (ii) Crack Propagation; and the (iii) Final Fracture Region.
